FACILITY CONDITION ASSESSMENT

SHENANDOAH OFFICE BUILDING

102 Heritage Way

EMG Project #: 79334.06R-002.138
Date of Report: December 7, 2006
On site Date: August 22, 2006

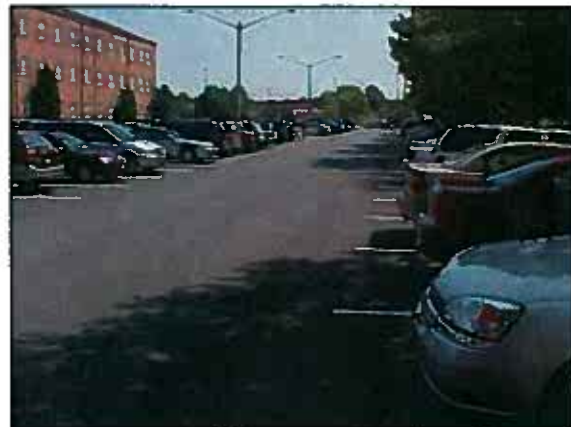
- The property does not have a dedicated paving repair and maintenance contractor. County maintenance personnel maintain the paving and flatwork or a contractor is retained when required.
- The asphalt pavement is in good to fair condition. However, there are several areas in the front parking lot showing signs of cracks and surface deterioration. These areas must be cut and patched immediately. The cost of this work is included in the Deficiency Cost Table.
- In order to maximize the pavement life, pothole patching, crack sealing, seal coating, and re-striping of the asphalt paving will be required during the assessment period. The cost of this work is included in the Deficiency Cost Table.
- The concrete curbs, gutters, and sidewalks throughout the property are in good condition. Routine cleaning and maintenance will be required during the assessment period.

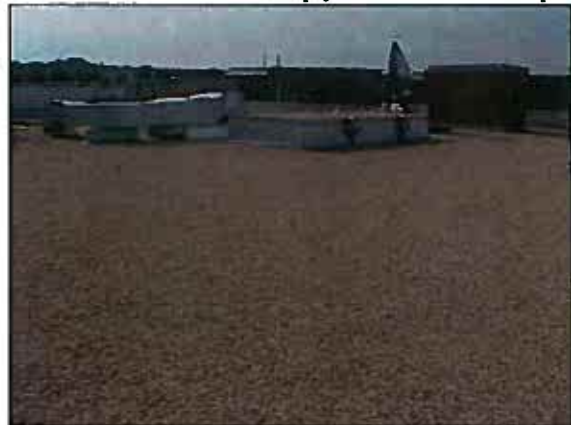
- The roof finishes are approximately one year old. Information regarding roof warranties or bonds were requested but are not available.
- There is no evidence of active roof leaks.

- The roof membranes are in good condition and will require routine maintenance during the assessment period.
- The roof shingles are in good condition and will require routine maintenance during the assessment period.

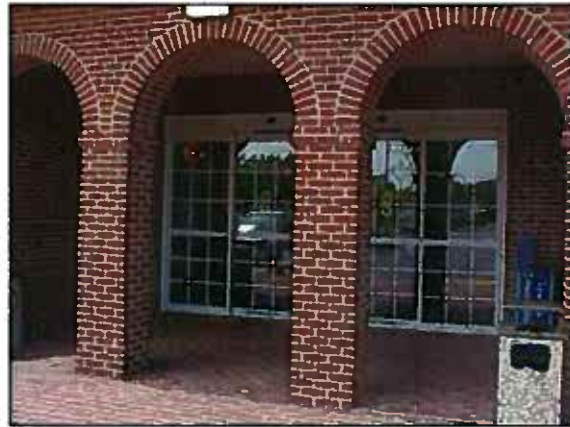
- The aluminum framed entrance doors are in good condition. Based on their estimated Remaining Useful Life (RUL), the doors will require replacement during the evaluation period. The estimated cost of this work is included in the Deficiency Cost Table.

- The windows are in fair condition. There is isolated evidence of leaks around some of the windows. Based on the estimated Remaining Useful Life (RUL) and current conditions, the windows will require replacement during the evaluation period. The estimated cost of this work is included in the Deficiency Cost Table.

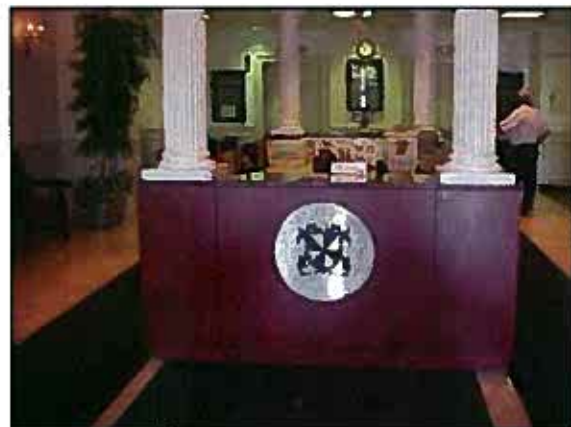
- It appears that the interior finishes have not been renovated within the last seven years.
- The interior finishes are in good to fair condition. Based on their estimated Remaining Useful Life (RUL), some of the flooring will require replacement during the assessment period. The cost of this work is included in the Deficiency Cost Table.
- Interior painting will also be required during the assessment period. The cost of this work is also included in the Deficiency Cost Table.
- Based on their estimated Remaining Useful Life (RUL), the ceiling tiles will require replacement during the assessment period. The cost of this work is included in the Deficiency Cost Table.

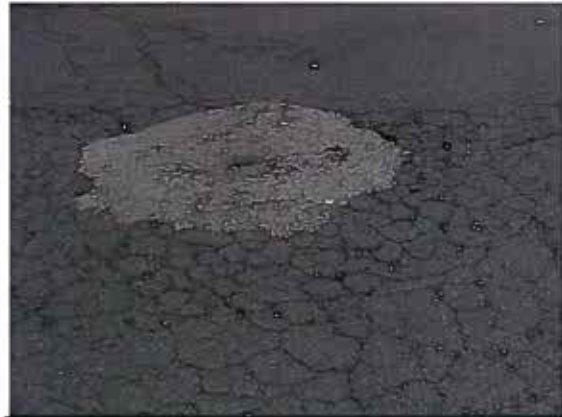
Photo #8: Asphalt deterioration in front parking lot area

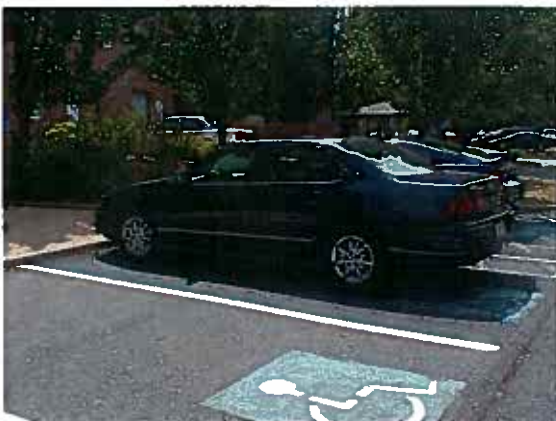
Photo #35: Missing ADA parking signage

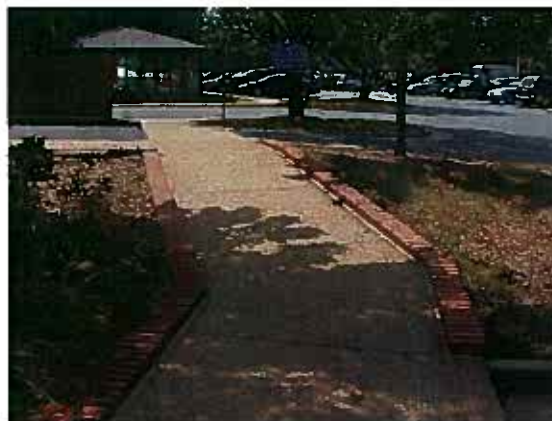
Photo #36: Missing ADA ramp/railings
